**Report on  
Investigation of a Contamination Risk  
Resulting from Exposures to Arsenic and Chromium  
from a  
Chromated Copper Arsenate (CCA) Treated Wood Deck  
in Ottawa, 2002**

Sierra Club of Canada  
July 2003

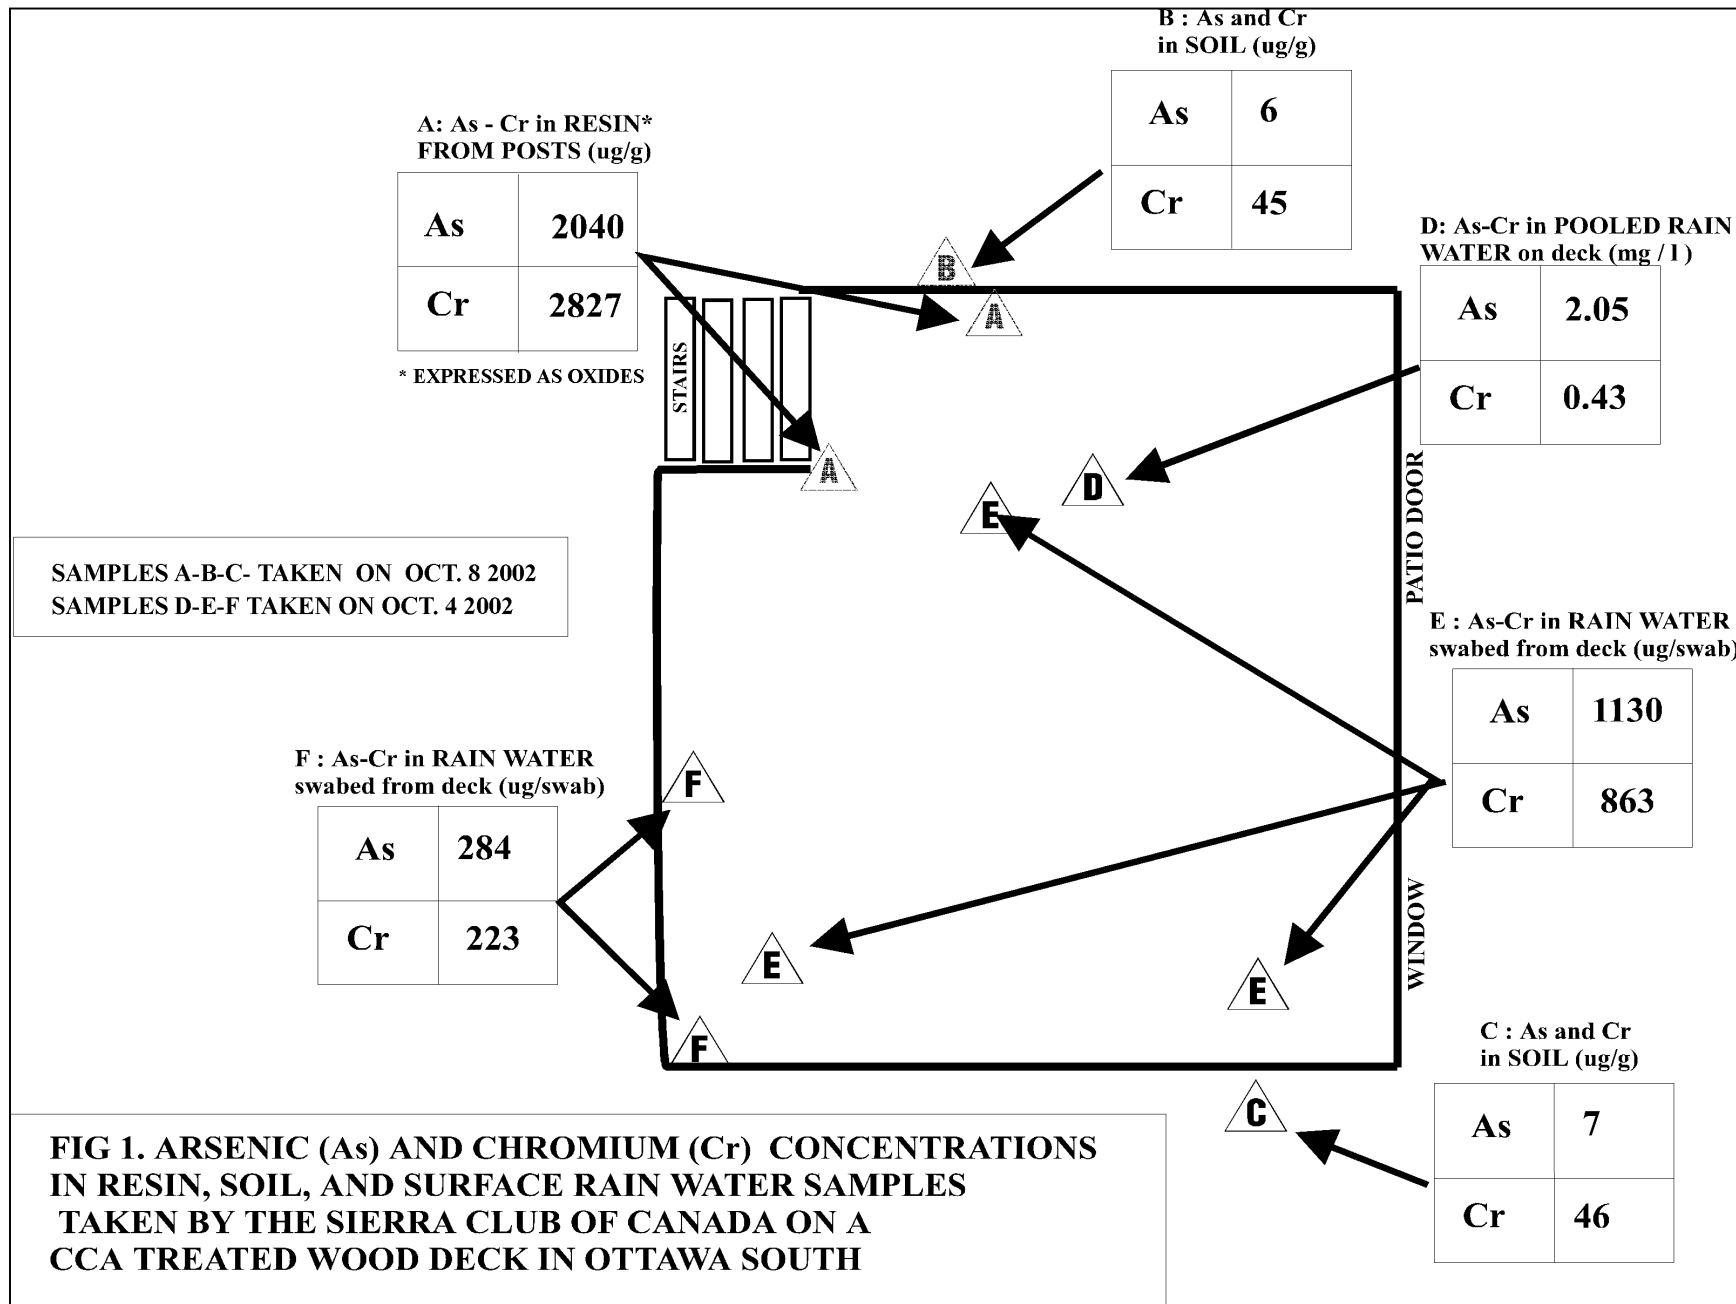
Figure 1 and 2 are diagrams of the deck showing the sampling points and the analysis results of SCC's and JW-Cooper sampling campaign respectively.

The highest concentrations of surface As and Cr were found in the resin on the surface of rail and corner posts (fig1, sample points A) and in a deck-board (fig. 2, sample point JW-4). These concentrations (in ug/g) are almost two orders of magnitude higher than the surface wipe test (given in ug/100 cm<sup>2</sup>, fig. 2 sample JW 1 to 4 –wipe test) performed by Cooper on the deck wood samples. For As in resin the range was 2040 to 2300 ug/g vs. 9 to 30 ug/cm<sup>2</sup> and for Cr in resin the range was 2500 to 2827 ug/g vs. 25 to 9 ug/cm<sup>2</sup>).

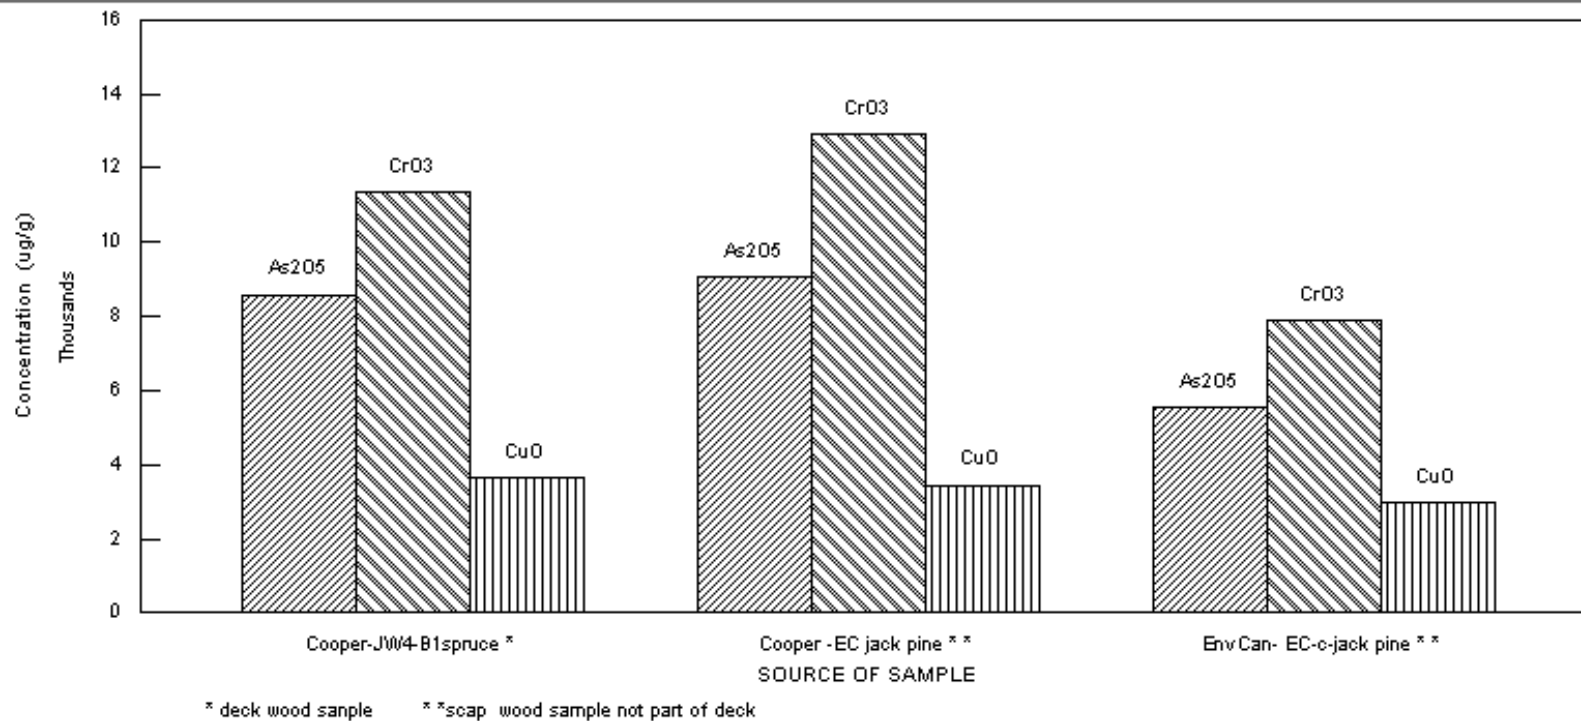
**Fig. 3 : Concentrations of CCA components in the wood of a treated deck and in scrap wood samples (1, 2)**

A comparison between CCA components between the two types of wood was done based on testing results from Cooper and Environment Canada. Figure 3 shows these results. The spruce wood from the deck (JW sample) compared to the jack pine (EC sample-not part of the deck,) show very little difference in CCA components in the treated margin of the two types of wood.

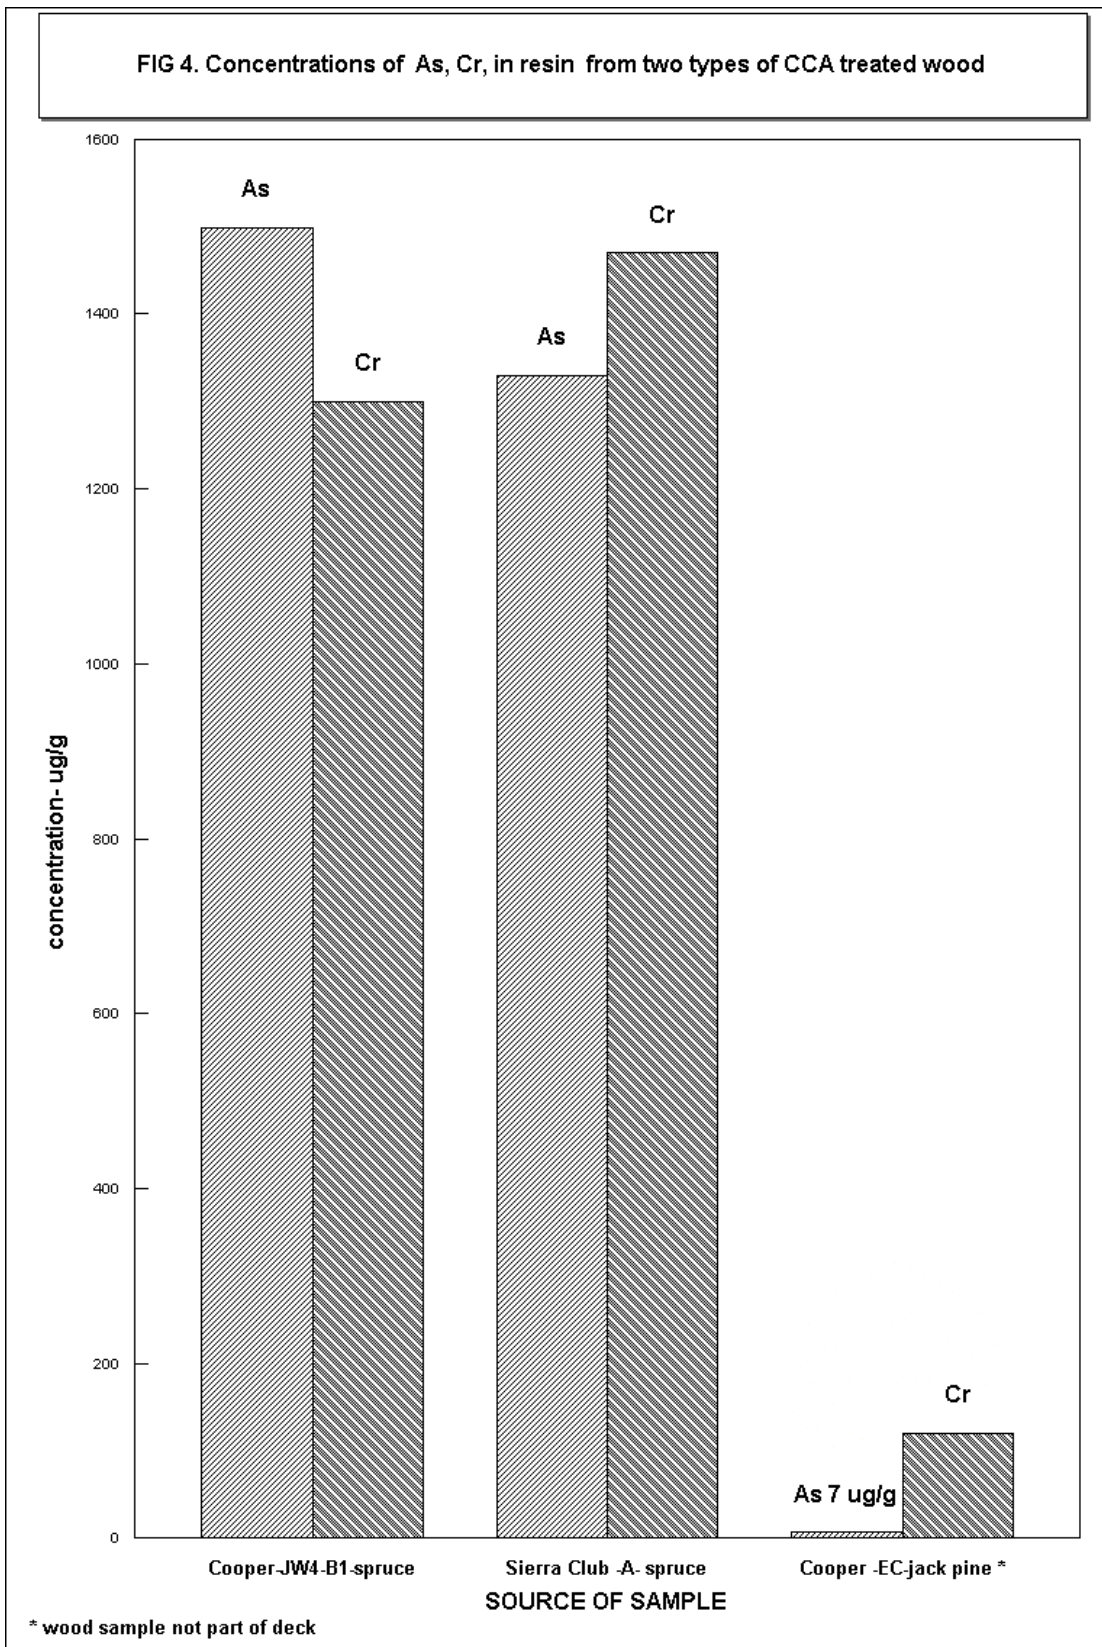
Figure 4: Comparison of As and Cr in resin from CCA treated spruce wood and jack pine.

But when SCC did the same comparison between the As and Cr concentrations in the resin sampled by SCC and Cooper from the CCA spruce deck wood versus scrap CCA treated jack pine wood sample (not part of the deck) we found extremely large differences between the two types of wood. Figure 4 (data log transformed) shows that both SCC's and Cooper's As–Cr concentrations in resin from the deck's spruce wood are almost identical (SCC did not have the Cu levels in resin analysed) while As-Cr levels in resin from the Cooper-EC jack pine (not part of deck) are comparatively very low (As conc. (ug/g) deck spruce wood vs. jack pine: 1330-1499 vs. 6.52. Cr conc. (ug/g) deck spruce wood vs. jack pine: 1300-1470 vs. 119.6). Thus ML's deck spruce wood has 217 times more As and 11 times more Cr in its surface resin than the surface resin of the jack pine wood sample.

Surface resin samples taken from CCA treated spruce wood cuttings of an Ottawa home wood deck by Dr. Cooper (dept. of Forestry, U. of Toronto) (Cooper-JW4-BI) deck and by the Sierra Club of Canada (Sierra Club -A-). These are compared to sampled resin from a CCA treated jack pine cutting (not part of the deck) submitted by Environment Canada. These results show that the resin from the CCA treated spruce deck wood contains a much higher arsenic and chromium concentration when compared to resin in a CCA treated jack pine cutting. CCA treated spruce deck wood surface resin contains arsenic levels that are 217 times the arsenic levels from in resin of CCA treated jack pine. The chromium in resin at the surface of the CCA treated spruce deck wood cuttings were 12 times higher than the chromium levels found in the resin of CCA treated jack pine. When this wood was used to build the Ottawa deck, exposure to the sun, summer heat, high humidity caused the CCA-laden resin to seep out of the spruce wood, creating surface CCA-resin pockets in the deck's planks and posts. From these resin pockets, resin containing high levels of arsenic and chromium oxides flowed on surfaces of the deck wood creating ideal dermal exposure conditions to sticky and highly contaminated resin for the users of this deck.

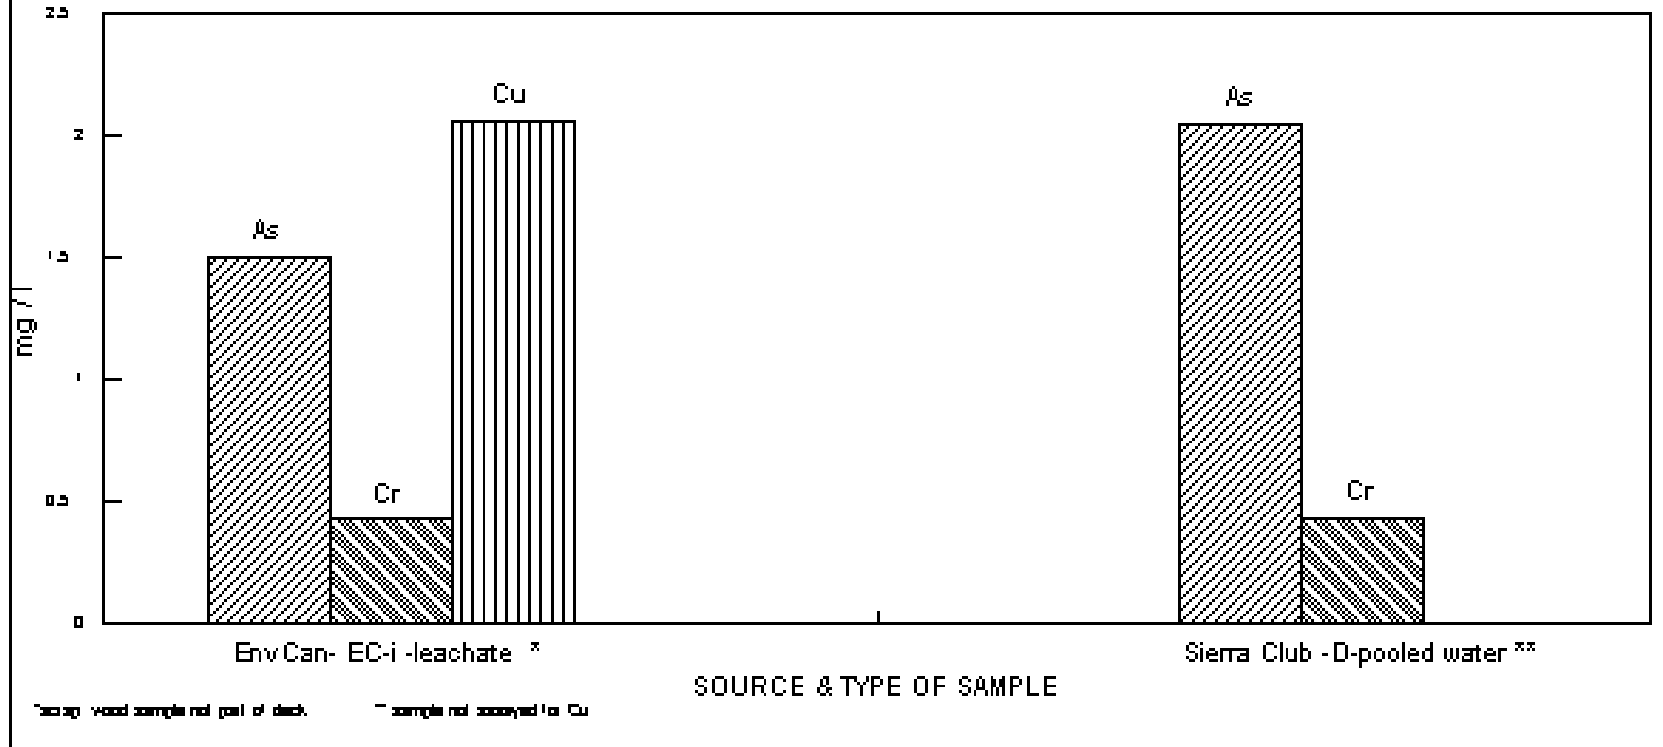
FIG5. Concentrations of As, Cr, Cu, in leachate tests (CCA jack pine )and pooled surface rain water from a CCA treated s

Analysis of pooled rainwater samples also yielded a high level of soluble As leaching from the deck. Figure 5 shows levels of CCA components in pooled rainwater on the deck and in water following extraction procedures (EP test) performed by Environment Canada on CCA treated jack pine sample (not part of deck). The passive leaching of As from the deck wood to rain water was measured at 2.05 mg /l compared to 1.5 mg As /l in water after the much more aggressive EP test (mulched wood mixed with acidic water) done on the jack pine. This seems to indicate that the CCA spruce wood used on the deck water less apt in retaining CCA components than the jack pine.
